POCANTICO LAKE DAM
WESTCHESTER COUNTY
NEW YORK
INVENTORY NO 49

PHASE I INSPECTION REPORT
NATIONAL DAM SAFETY PROGRAM

National Dam Safety Program.
Pocantico Lake Dam, Lower Hudson River
Basin, Westchester County, New York
(Inventory Number 49), Phase I
Inspection Report.

AUGUST 1978

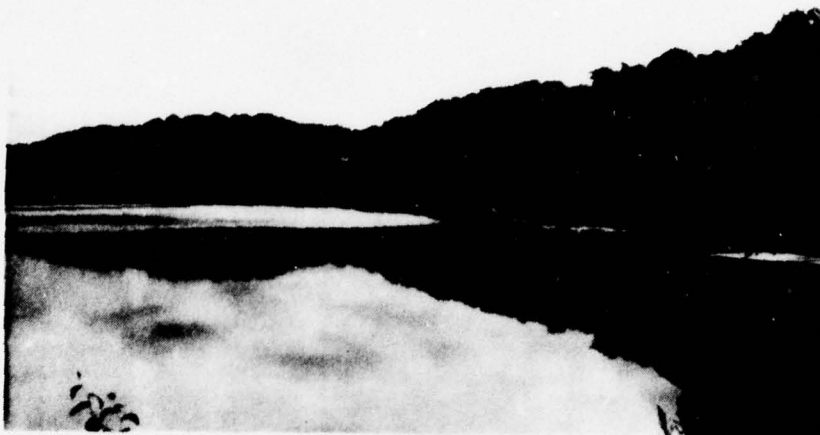
3. View of reservoir upstream of dam.

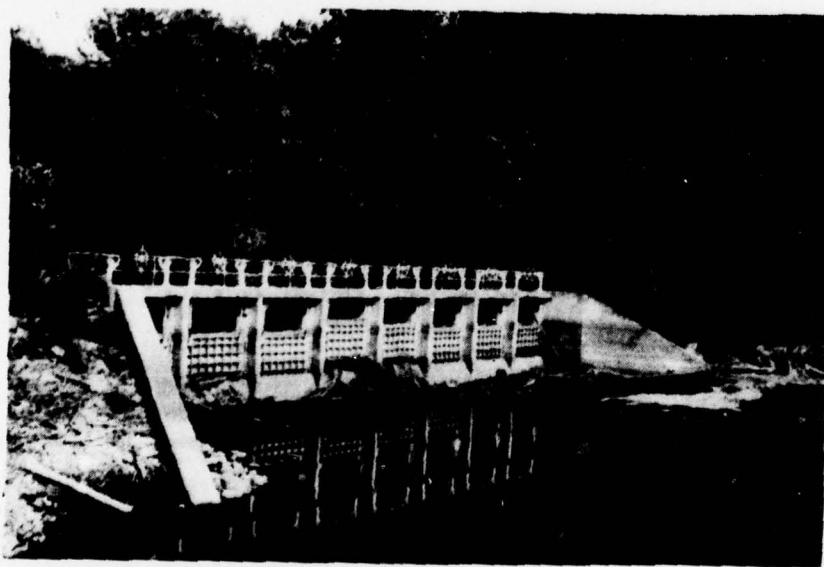
4. View of spillway structure with eight 8 X 4 sluice gates.

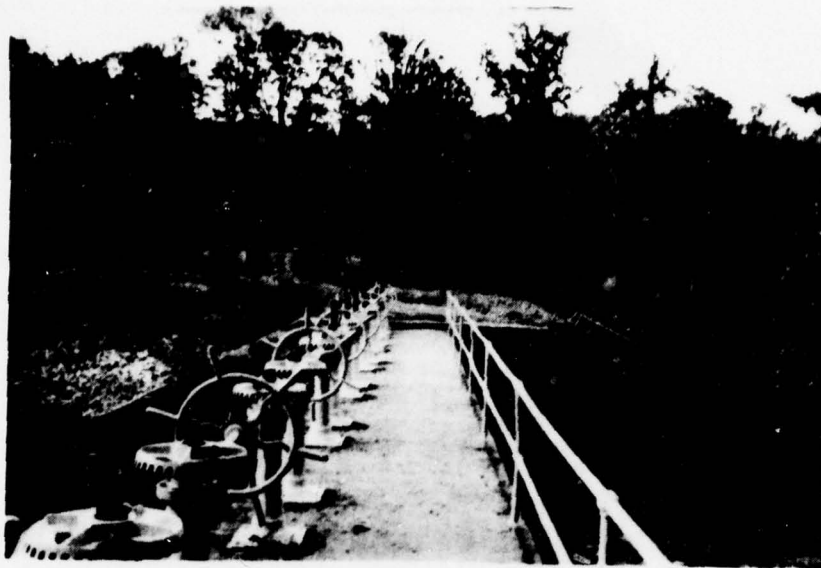
5. Manually operated gate equipment.

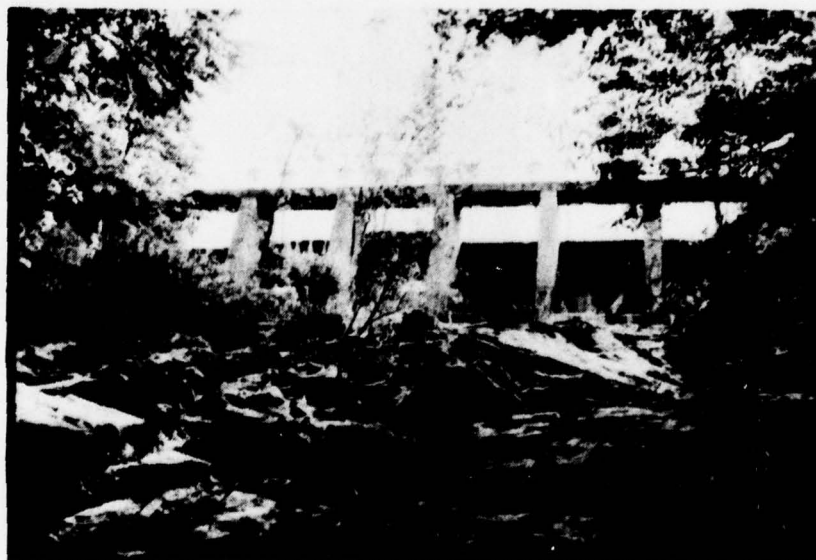
6. View of spillway from downstream channel.

The channel immediately below the spillway is shown in Photograph 6. It is largely exposed rock. Photograph 10 shows some embankment erosion further downstream. This is not considered serious.

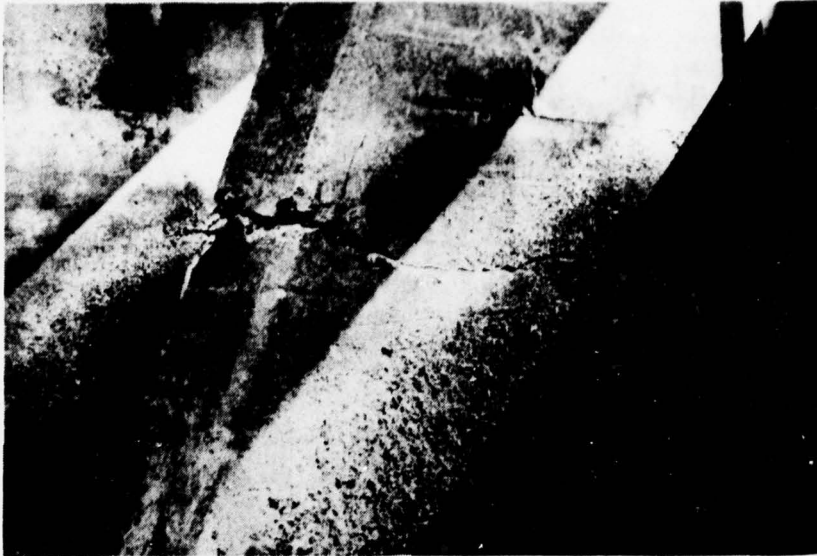
7. Detail of spillway gate dividing wall showing cracks.

The spillway concrete sill shown in Photograph 8 is in fair condition. Some wear of the surface material has taken place. One of the spillway's dividing wall and support frame for the sluice gates is cracked as shown in Photograph 7. The spillway gates, shown in Photograph 5, are reported to be operable but are not well maintained so as to be easily operated.

The spillway structure should be kept clear of debris which could interfere with proper operation of sluice gates and spillway flow. Repair of damaged/deteriorated concrete in the spillway structure should be undertaken to prevent progressive effects. The area downstream of the spillway should be kept clear of debris and plant growth which could interfere with rapid passage of waste water.

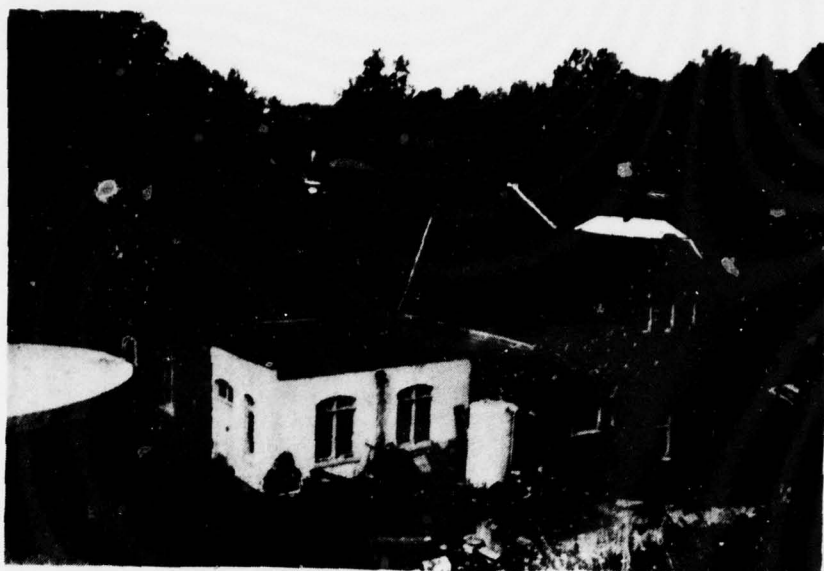
11. Abandoned filtration plant below dam.

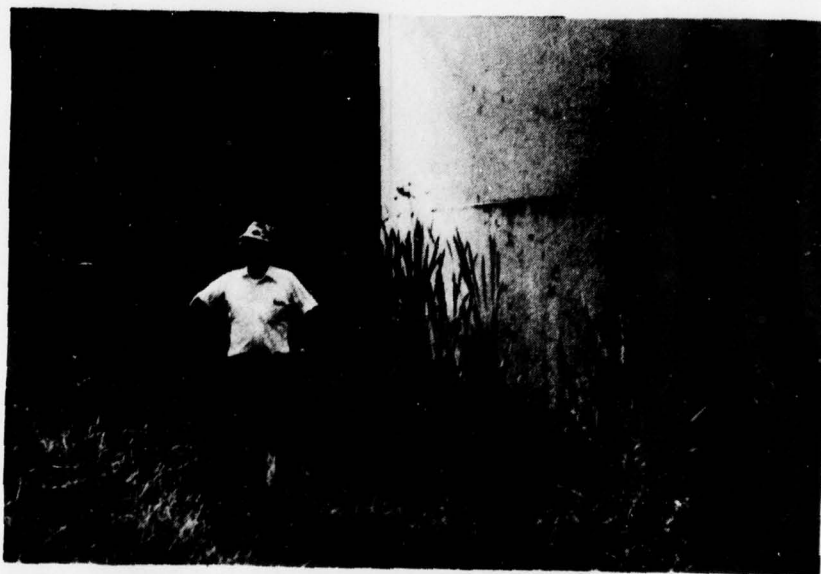
12. Cattails at toe of embankment near storage tank. Wetness from either seepage or poor surface drainage.

Some seepage was noted near the toe of the slope provided for the abandoned concrete settling tanks located immediately downstream of the dams easterly abutment. A low stone retaining wall has been constructed at the seepage location. The seepage condition apparently has been on-going for a considerable number of years. It appears that the seepage is from a spring or other source outside of the reservoir embankment area.

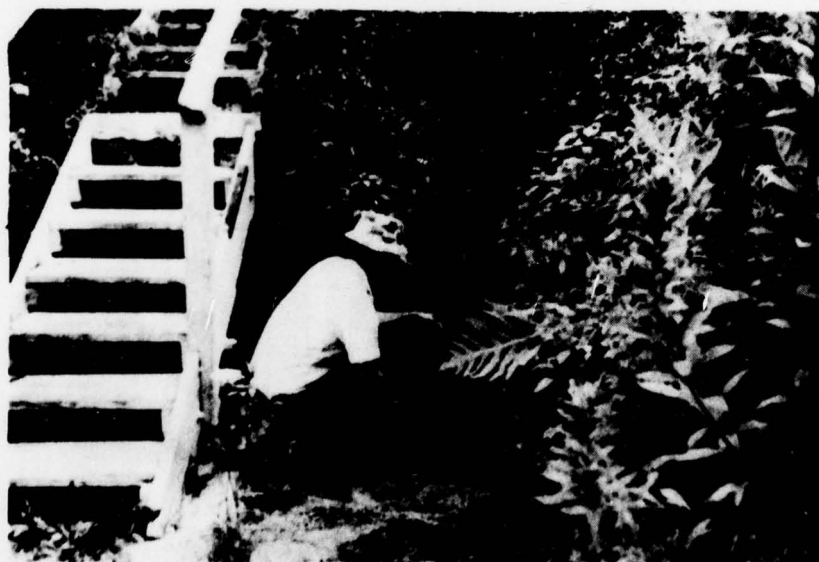
14. Cavity in east abutment embankment area below dam. Some water flowing.
